**Flood Control Project Maintenance  
Levee Inspections**  
**LMA District Cover Sheet**  
**Spring 2015 Levee Inspection Results**

**Reclamation District No. 2085 Kasson**

**Levee Inspection Report By Mile - Spring 2015**

Waterway	Bank	Unit Miles	Inspection Start/End	Inspector
Unit No. 01 San Joaquin River	Left	5.29	04/09/2015 04/09/2015	Maksim Khashchuk

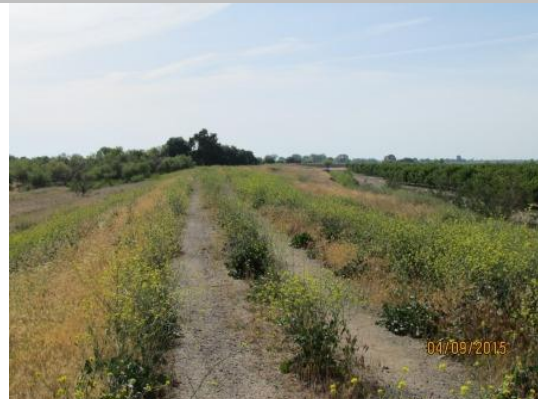
Photo 1 of 1 : SP\_2015\_RD2085\_113\_19\_20150413\_00018.jpg

LM Start	0.59	Rating **	M	Issue No.	19
LM End	0.93	Issue Type +	Ma	Location *	LS
Category	Earthen Levee			GPS Latitude/Longitude	
				Start	End
Item	Vegetation			37.722926 °	37.719517 °
				-121.297681 °	-121.293333 °
DWR ID	DWR_RD2085_01_s_2015_19

View of the annual vegetation on the levee.

Action/Comments					
Control annual grass and weeds on the levee slopes and easements.

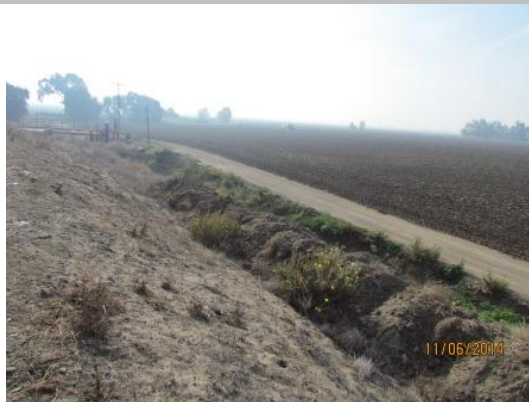
Photo 1 of 1 : SP\_2015\_RD2085\_113\_6\_20150317\_00003.jpg

LM Start	1.34	Rating **	M	Issue No.	6
LM End	1.38	Issue Type +	En	Location *	LS
Category	Earthen Levee			GPS Latitude/Longitude	
				Start	End
Item	Encroachments			37.714265 °	37.714056 °
				-121.289641 °	-121.289069 °
DWR ID	DWR_RD2085_01_s_2012_6				
Action/Comments					
Ditch					
Inspector Comments: Drainage ditch at levee toe.

View of the ditch at the landside levee toe.

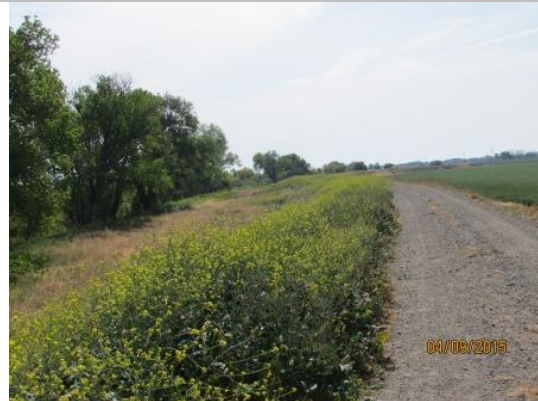
Photo 1 of 1 : SP\_2015\_RD2085\_113\_21\_20150413\_00019.jpg

LM Start	1.47	Rating **	M	Issue No.	21
LM End	2.12	Issue Type +	Ma	Location *	WS
Category	Earthen Levee			GPS Latitude/Longitude	
				Start	End
Item	Vegetation			37.713617 °	37.708475 °
				-121.287497 °	-121.277871 °
DWR ID	DWR_RD2085_01_s_2015_21				
Action/Comments					
Control annual grass and weeds on the levee slopes and easements.

View of the annual vegetation on the waterside slope.

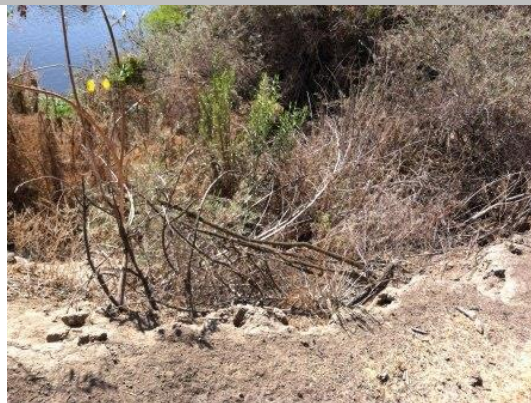
Photo 1 of 1 : SP\_2015\_RD2085\_113\_1\_20150317\_00001.jpg

LM Start	2.57	Rating **	M	Issue No.	1
LM End	2.57	Issue Type +	Ma	Location *	WS
Category	Supplemental			GPS Latitude/Longitude	
				Start	End
Item	DWR Erosion Survey			37.703094 °	37.703094 °

121.274894 °	121.274894 °
DWR ID	DWR_RD2085_01_s _ 2015_1				
Action/Comments					
Inspector Comments: 09/20/2013: No significant change in erosion observed. More vegetation at the site. 12/04/2012: The erosion has progressed remarkably toward levee, extended to the up-and downstream of the original pocket erosion. Trees and dense bush are present at the site. Animal burrow holes are visible, and possibly can cause seepage. 09/22/2010: No significant change observed. There is little visibility due to seasonal grass on the berm and slope. 08/18/2009: Site is located on berm; pocket erosion has developed; the site is covered in dense vegetation; there are several relief wells on the landside of the levee; site is Not Rated because berm width is greater than 30 feet; site should be monitored to keep track of erosion progress. [2014 Site ID:RD2085U01RM66.5]

Direct view of the erosion. Note dense vegetation at the site.

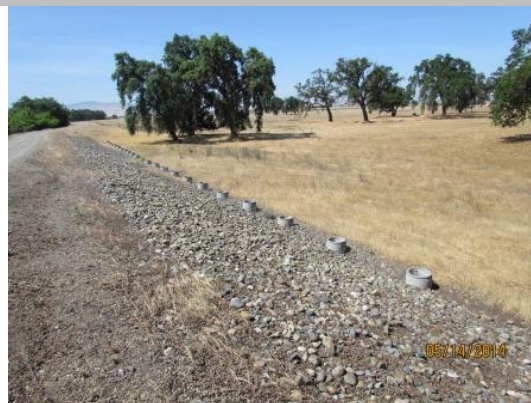
Photo 1 of 1 : SP\_2015\_RD2085\_113\_20\_20150317\_00005.jpg

LM Start	2.58	Rating **	A/W	Issue No.	20
LM End	2.58	Issue Type +	Ob	Location *	LS
Category	Earthen Levee			GPS Latitude/Longitude	
				Start	End
Item	Underseepage Relief Wells			37.702903 °	37.702903 °
				-121.274860 °	-121.274860 °
DWR ID	DWR_RD2085_01_s _ 2012_20				
Action/Comments

View of the underseepage relief wells at the landside levee toe.

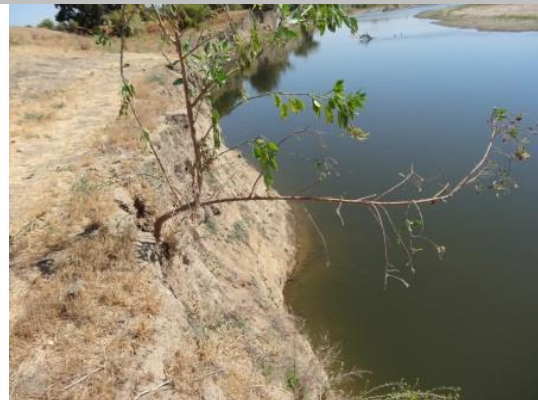
Photo 1 of 1 : SP\_2015\_RD2085\_113\_2\_20150317\_00002.jpg

LM Start	3.68	Rating **	A/W	Issue No.	2
LM End	3.68	Issue Type +	Ma	Location *	WS
Category	Supplemental			GPS Latitude/Longitude	
				Start	End
Item	DWR Erosion Survey			37.688545 °	37.688545 °
				-121.276298 °	-121.276298 °
DWR ID	DWR_RD2085_01_s_2015_2				
Action/Comments					
Inspector Comments: 7/17/2014: No significant change observed. 09/10/2013: No significant change observed. 12/04/2012: This site has been documented before, and a cost estimate to repair has been prepared dated 05/09/2010. The fresh cut shows the erosion is developing. The berm width is at least 42 feet. Sticks were placed at three locations along the river bank, with 3 sticks 5 feet apart at each location. [2014 Site ID:RD2085U01RM67.7]

Direct view of the erosion.

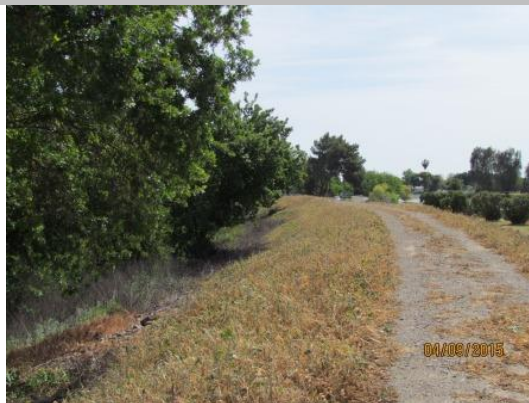
Photo 1 of 1 : SP\_2015\_RD2085\_113\_54\_20150413\_00020.jpg

LM Start	4.26	Rating **	M	Issue No.	54
LM End	4.53	Issue Type +	Ma	Location *	WS
Category	Earthen Levee			GPS Latitude/Longitude	
				Start	End
Item	Vegetation			37.681886 °	37.681332 °
				-121.272333 °	-121.267518 °
DWR ID	DWR_RD2085_01_s_2012_54				
Action/Comments					
Remove the wild growth other than native grasses from the levee slopes.

View of the vegetation on the waterside levee slope.

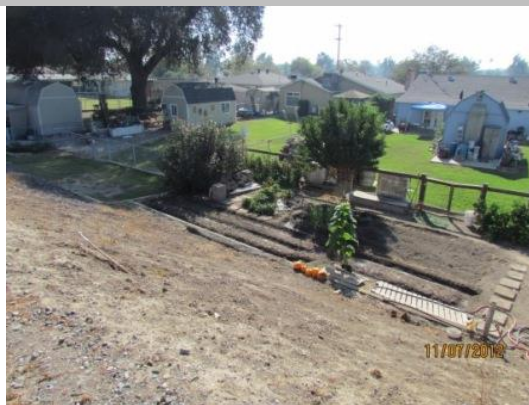
Photo 1 of 2 : SP\_2015\_RD2085\_113\_33\_20150317\_00007.jpg

LM Start	4.40	Rating **	M	Issue No.	33
LM End	4.45	Issue Type +	En	Location *	LS
Category	Earthen Levee			GPS Latitude/Longitude	
				Start	End
Item	Vegetation			37.681863 °	37.681640 °
				-121.269856 °	-121.269046 °
DWR ID	DWR_RD2085_01_s_2012_33				
Action/Comments					
Landscaping

Updated photo of encroachments on landside toe.

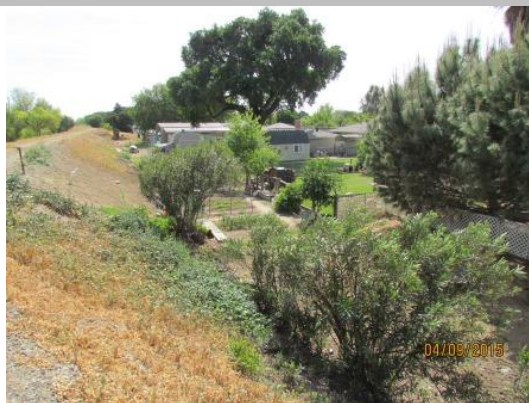
Photo 2 of 2 : SP\_2015\_RD2085\_113\_33\_20150413\_00021.jpg

LM Start	<b>4.40</b>	Rating **	M	Issue No.	<b>33 (cont)</b>
LM End	<b>4.45</b>	Issue Type +	En	Location *	LS

View of the landscaping at the landside levee slope.

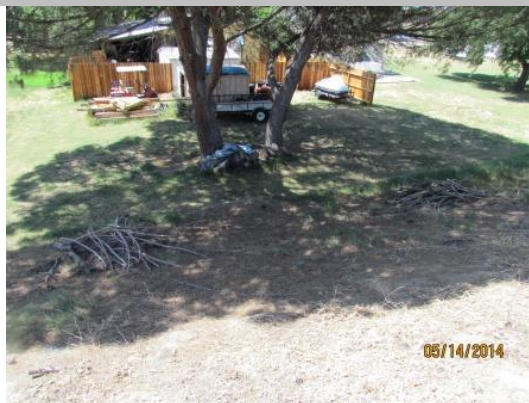
Photo 1 of 1 : SP\_2015\_RD2085\_113\_17\_20150317\_00004.jpg

LM Start	4.59	Rating **	M	Issue No.	17
LM End	4.59	Issue Type +	En	Location *	LS
Category	Earthen Levee			GPS Latitude/Longitude	
				Start	End
Item	Encroachments			37.681158 °	37.681158 °
				-121.266587 °	-121.266587 °
DWR ID	DWR_RD2085_01_f_2013_17				
Action/Comments					
Firewood

View of the firewood stored at the landside levee toe.

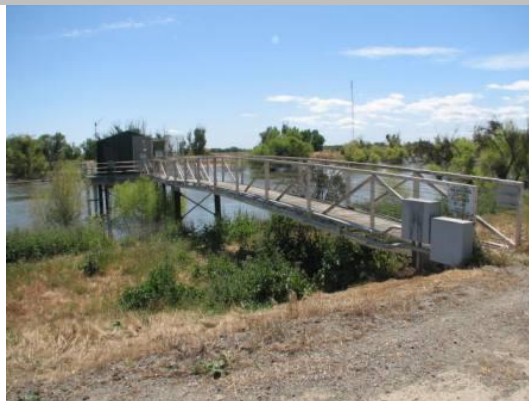
Photo 1 of 1 : SP\_2015\_RD2085\_113\_36\_20150317\_00009.jpg

LM Start	4.78	Rating **	A/W	Issue No.	36
LM End	4.78	Issue Type +	En	Location *	WS
Category	Earthen Levee			GPS Latitude/Longitude	
				Start	End
Item	Encroachments			37.679527 °	37.679527 °
				-121.265367 °	-121.265367 °
DWR ID	DWR_RD2085_01_s_2012_36				
Action/Comments					
Building					
Inspector Comments: Monitoring station on waterward side.

04/28/2011 Monitoring station.

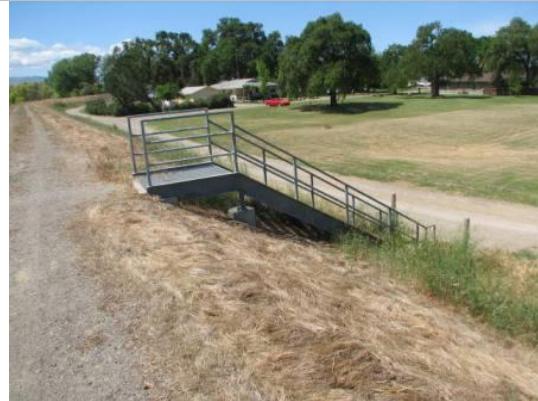
Photo 1 of 1 : SP\_2015\_RD2085\_113\_35\_20150317\_00008.jpg

LM Start	4.78	Rating **	A/W	Issue No.	35
LM End	4.78	Issue Type +	En	Location *	LS
Category	Earthen Levee			GPS Latitude/Longitude	
				Start	End
Item	Encroachments			37.679526 °	37.679526 °
				-121.265367 °	-121.265367 °
DWR ID	DWR_RD2085_01_s_2012_35				
Action/Comments					
Stairway					
Inspector Comments: Stairs for monitoring station on landside slope.

04/28/2011 Stairs on landside slope for monitoring station.

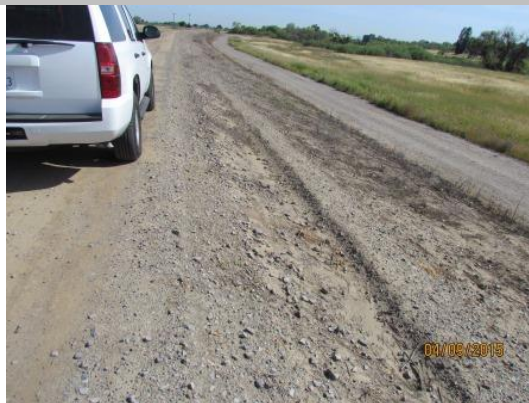
Photo 1 of 1 : SP\_2015\_RD2085\_114\_3\_20150413\_00002.jpg

LM Start	0.46	Rating **	M	Issue No.	3
LM End	0.46	Issue Type +	Ma	Location *	LS
Category	Earthen Levee			GPS Latitude/Longitude	
				Start	End
Item	Crown Surface / Depressions / Rutting			37.710991 °	37.710991 °
				-121.271462 °	-121.271462 °
DWR ID	DWR_RD2085_02_s_2015_3				
Action/Comments					
Repair depressions or ruts in the crown or slope.

View of the tire depression on the levee slope.

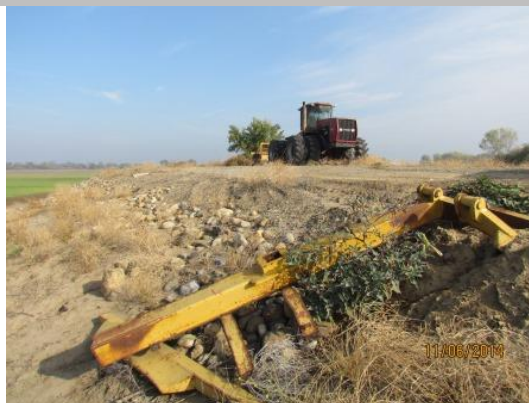
Photo 1 of 1 : SP\_2015\_RD2085\_114\_1\_20150317\_00001.jpg

LM Start	0.68	Rating **	M	Issue No.	1
LM End	0.68	Issue Type +	En	Location *	CR
Category	Earthen Levee			GPS Latitude/Longitude	
				Start	End
Item	Encroachments			37.713838 °	37.713838 °
				-121.269690 °	-121.269690 °
DWR ID	DWR_RD2085_02_s_2012_1				
Action/Comments					
Equipment					
Inspector Comments: Heavy equipment is being stored on the levee crown. Remove equipment from levee slope.

View of farming equipment being stored on the levee crown at the end of the spur levee.

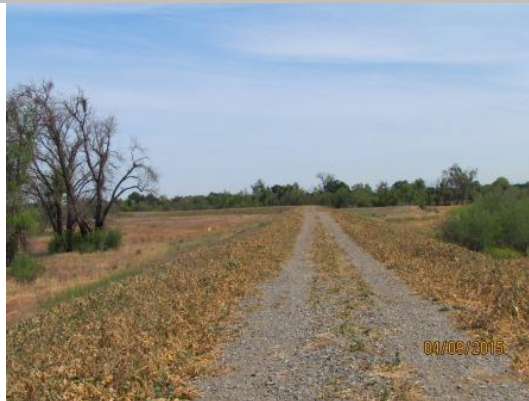
Photo 1 of 1 : SP\_2015\_RD2085\_115\_4\_20150413\_00002.jpg

LM Start	0.02	Rating **	M	Issue No.	4
LM End	0.02	Issue Type +	Ma	Location *	WS
Category	Earthen Levee			GPS Latitude/Longitude	
				Start	End
Item	Vegetation			37.680772 °	37.680772 °
				-121.264359 °	-121.264359 °
DWR ID	DWR_RD2085_03_s_2015_4				
Action/Comments					
Remove the wild growth other than native grasses from the levee slopes.

View of the vegetation on the levee slopes.

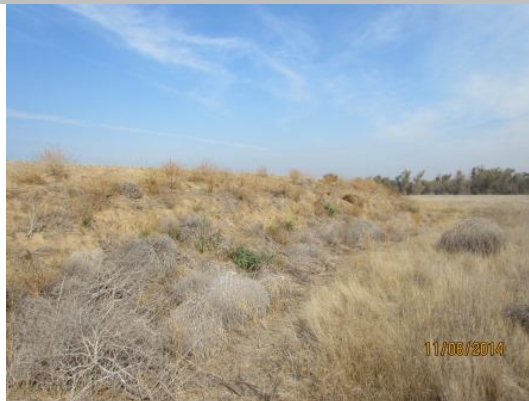
Photo 1 of 1 : SP\_2015\_RD2085\_115\_1\_20150317\_00001.jpg

LM Start	0.21	Rating **	U	Issue No.	1
LM End	0.23	Issue Type +	Ma	Location *	WS
Category	Earthen Levee			GPS Latitude/Longitude	
				Start	End
Item	Erosion / Bank Caving			37.682798 °	37.683052 °
				-121.262059 °	-121.261851 °
DWR ID	DWR_RD2085_03_s_2014_1				
Action/Comments					
Schedule repair of erosion site prior to the next inspection. Inspector Comments: Erosion of the waterside levee slope has been observed. The erosion is about 3 feet tall vertical from the slope to the base of projected levee toe.

View of the erosion at the waterside levee toe.
